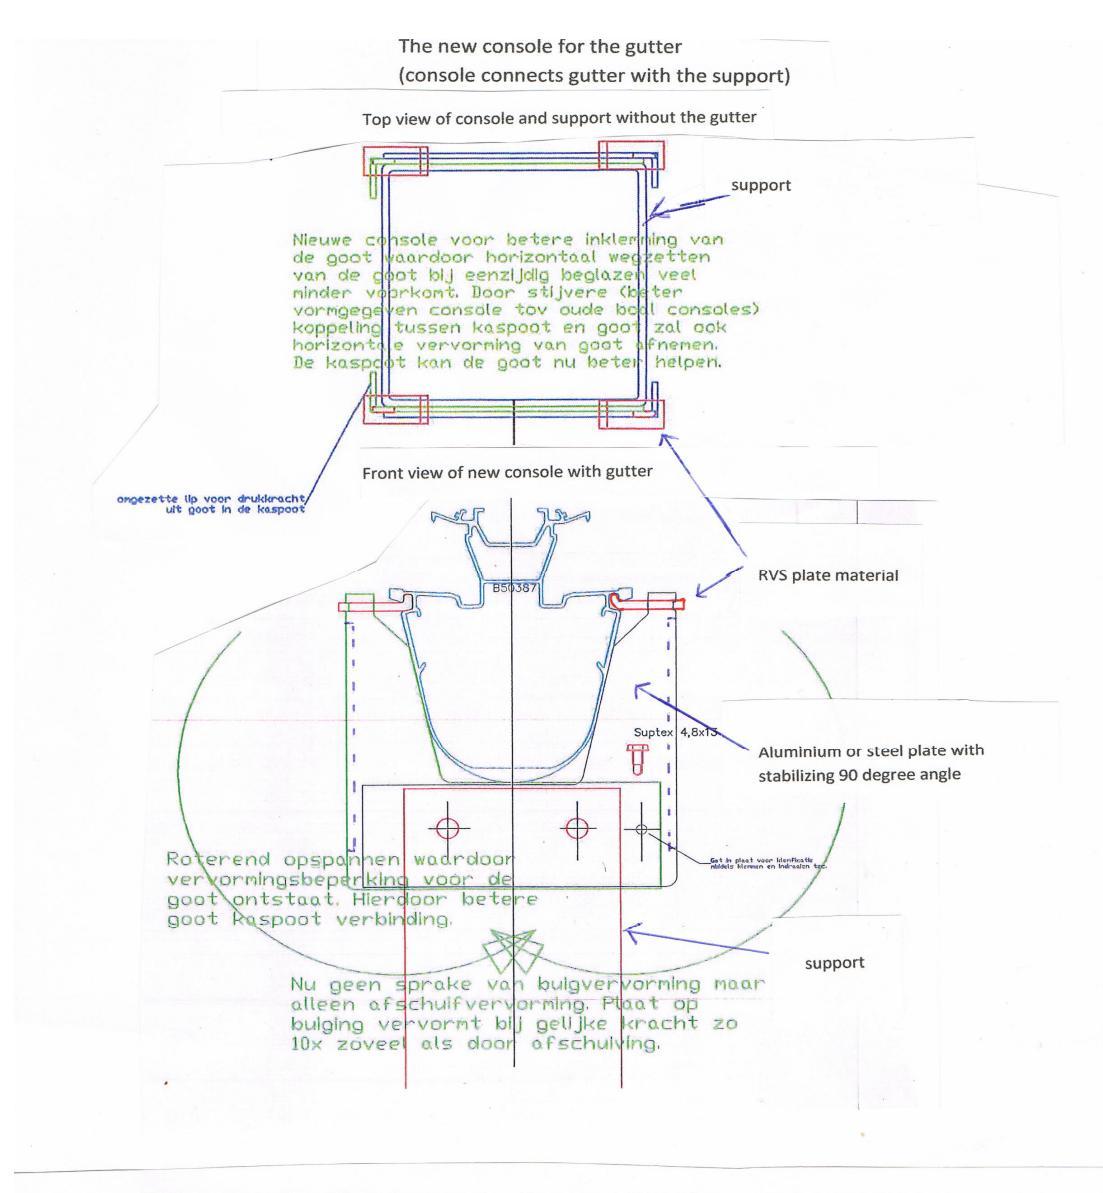
Above you see a cross section of something more as half of a part of the roof of a greenhouse. The greenhouse consists of several roofs next to each other. During glazing a part of the roof next to this roof in above picture is not glazed jet. Due to the high weight of the glass the gutter in above picture will be bent outward (see black arrow in above picture). Due to this bending there is less space to place the glass on the next roof. Due to this the gutter needs to have a high horizontal bending stiffness. If we can connect the gutter with the supports in a stiffer way the outward bending of the gutter will be lowered. The console connects the gutter with the supports (see red hatched part in above picture). This console is about 20 centimeters long and is secured with the gutter with two or more pop rivets. The console is bolted on the supports. This console is not stiff because not much material is oriented in the direction of the force (black arrow in above picture). I tested new kinds of consoles. The best new design (see underneath picture) did bent out 8 times less compared with the old console. Also the rotation of the gutter was lowered with a factor 5. So this new console lowers the bending and rotation of the gutter. If we accept the same amount of bending with the new console the gutter can be made less stiff. This means a weight reduction of the gutter. Also the cover plate welded on top of the supports is not necessary anymore.

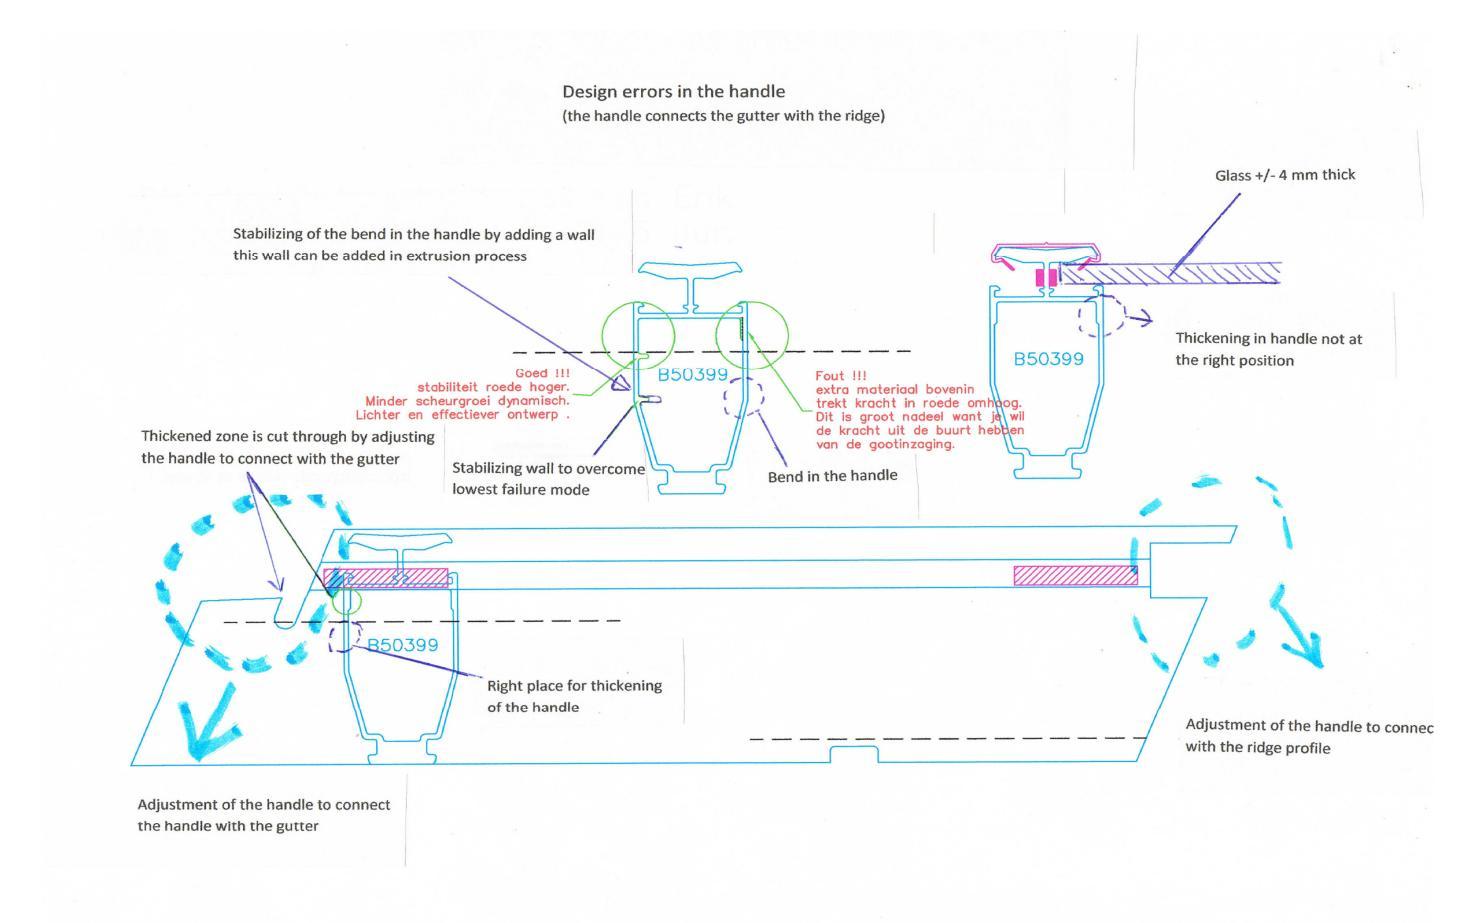
I also did tests on the connection between gutter and handle. With this test the handle was pulled out of the gutter. TNO (Dutch company) does these tests in the same way to confirm with NEN construction standards. During my tests some design errors came up (see underneath picture). When we look at the cross section of the handle we see an extra material thickness at the top of the cross section. The aim of this extra material was to strengthen the connection between gutters and handle. The handle has to be adapted to connect with the gutter (see dotted blue line at the left of this drawing). Due to this saw treatment the thickening is cut through. The thickening should be placed in a lower position. In the cross section drawing we can also see a bend in the handle. During tests of breaking the connection between handle and gutter I saw that this bend causes the breakdown of this connection. See the drawing below.

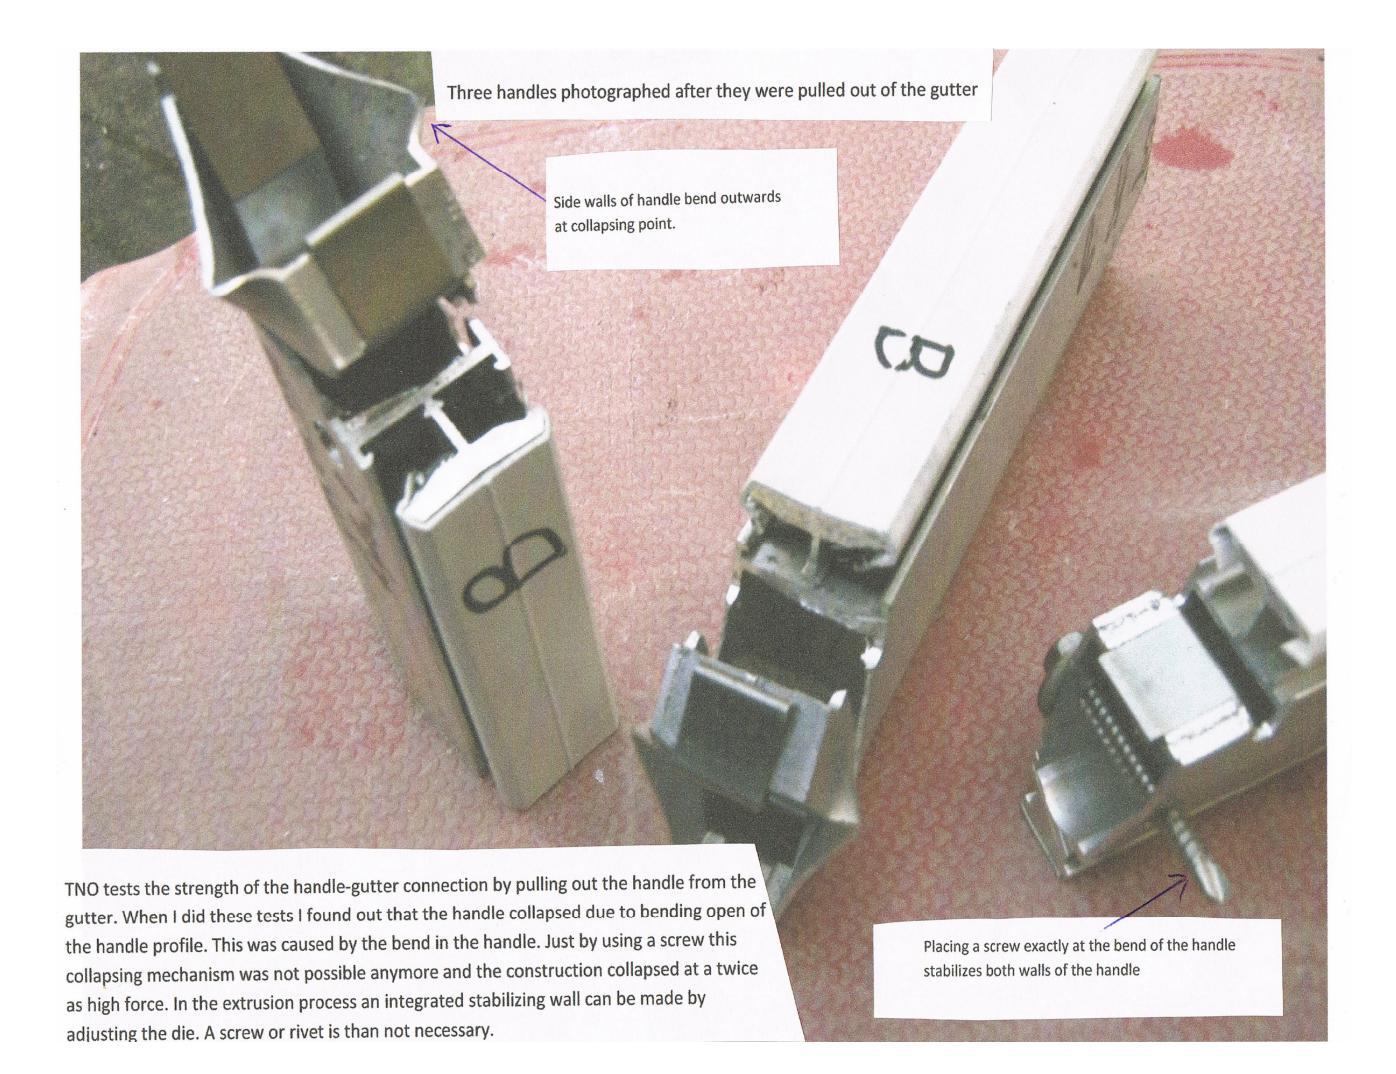
The two handles at the left of underneath picture failed from the bend in the handle. Just by connecting both sidewalls of the handle (connect the sidewalls exactly where the bend is) with a screw or pop rivet collapsing force was raised from 100 to 200 kilo's (1 kilo is 10 Newton force). Due to this, not the handle is the weak part but the gutter. Off course no screw or pop rivet is necessary to stabilize the side walls of the handle. Just by adjusting the extrusion die we can add some extra material just were the bend is in the handle. This extra wall (see above cross section of the handle) will also stabilize the bend in the handle. Underneath you see a picture of three handles after the tests. The two handles on the right did collapse due to the bend in the cross section of the handle. By using a pop rivet this collapse mechanism is excluded. That is why collapsing will than take place at a higher force and another failure mechanism.

By application of the new console and the improvements in the design of the handle it can be possible to make the gutter and handle thinner. A weight reduction of about 10 until 15% is possible. Due to the fact that aluminum is very expensive the profit of this firm could raise from 5 to 10%.
